**US Army Corps  
of Engineers**

**TECHNICAL REPORT REMR-COS**

**CASE HISTORIES OF CORPS BREAKWATER  
AND JETTY STRUCTURES**

**Report 6  
NORTH PACIFIC DIVISION**

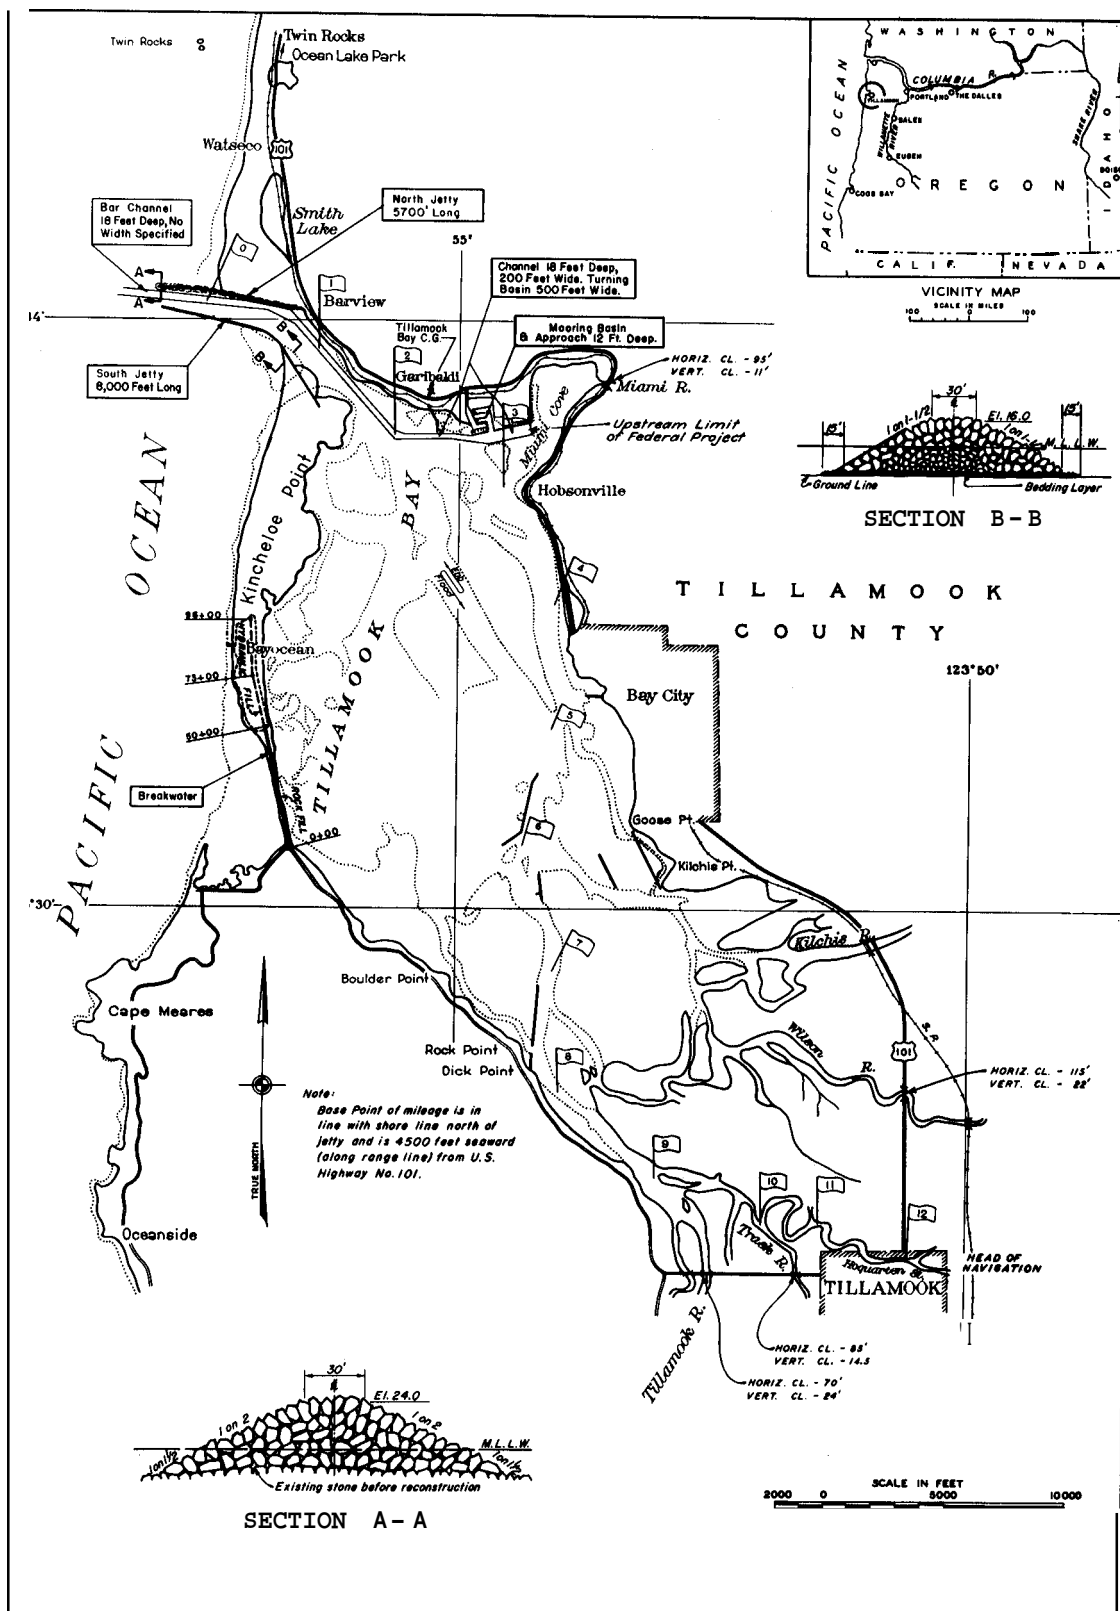
| <u>Date(s)</u> | <u>Construction and Rehabilitation History</u> |
|---|--|
| 1985 | The harbor and cross sections of the jetties are illustrated in Figure 63. The head of the north jetty has received some damage from extreme wave conditions, and the outer portion of the south jetty has shown some subsidence. No repairs or rehabilitation are planned at this time. |

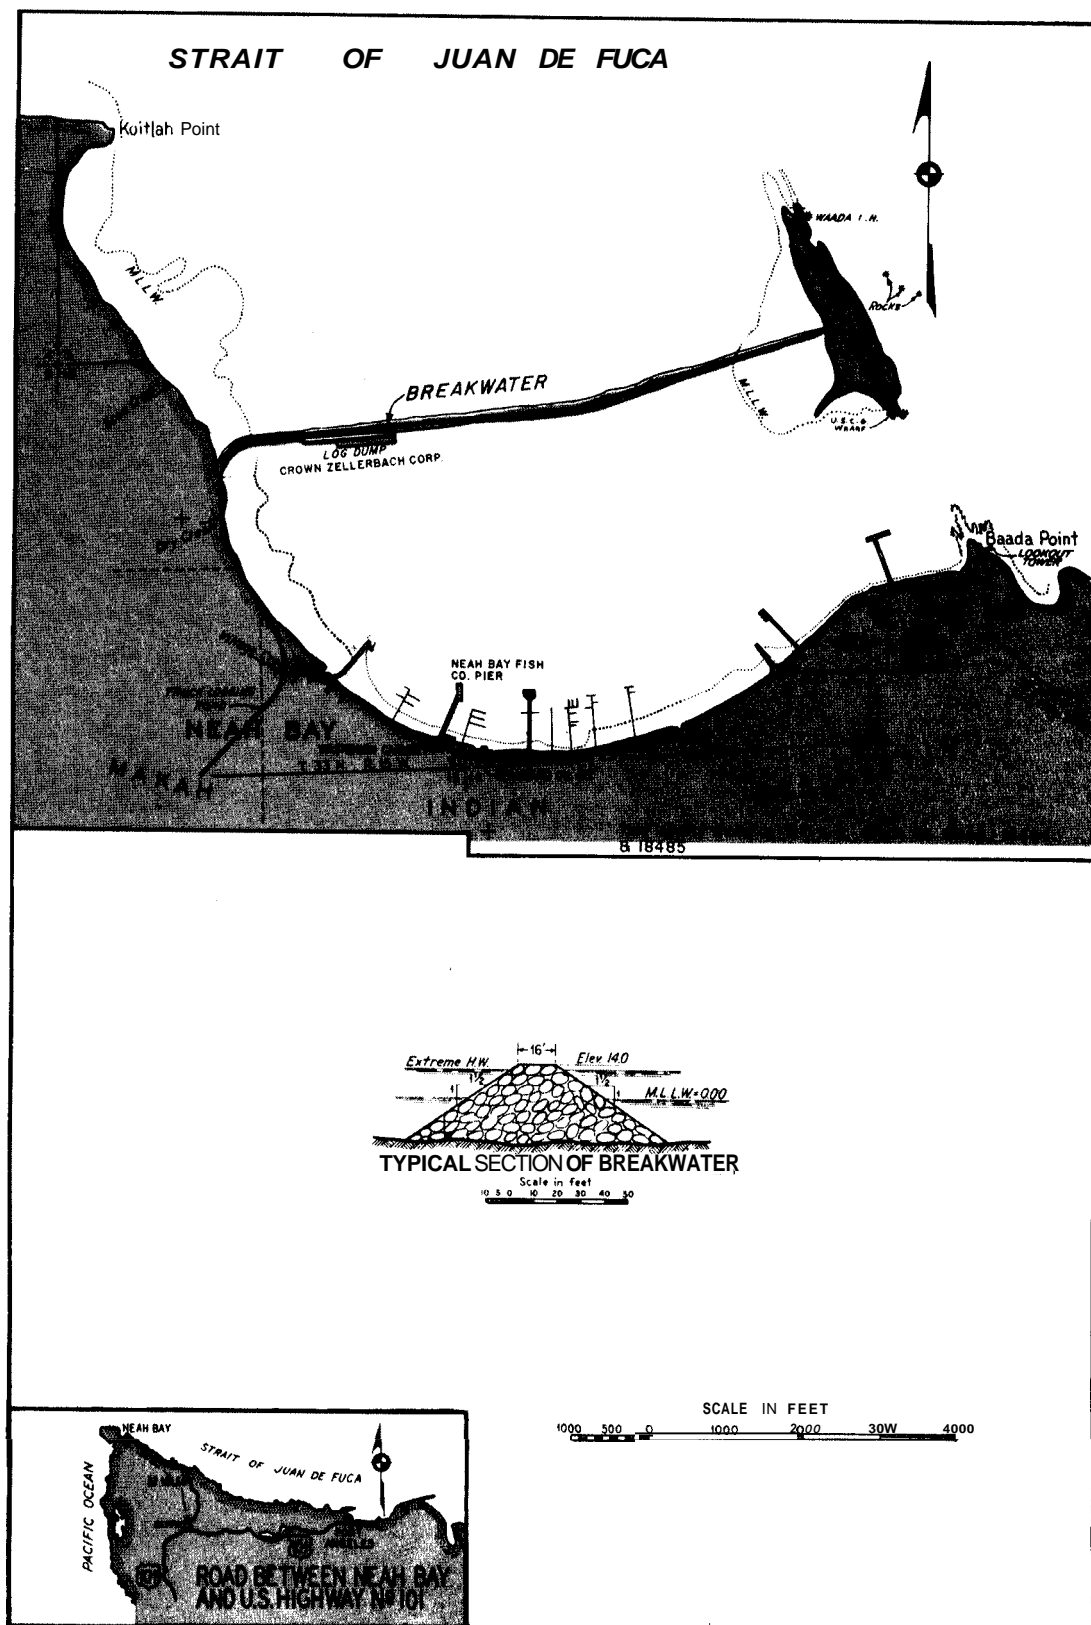
Figure 73. Site layout at Neah Bay, Washington (revised 1979)

| Date( s) | Construction and Rehabilitation History |
|---|--|
| 1985 | The harbor and cross section of the breakwater are illustrated in Figure 73. The breakwater appears in good condition at this time, |

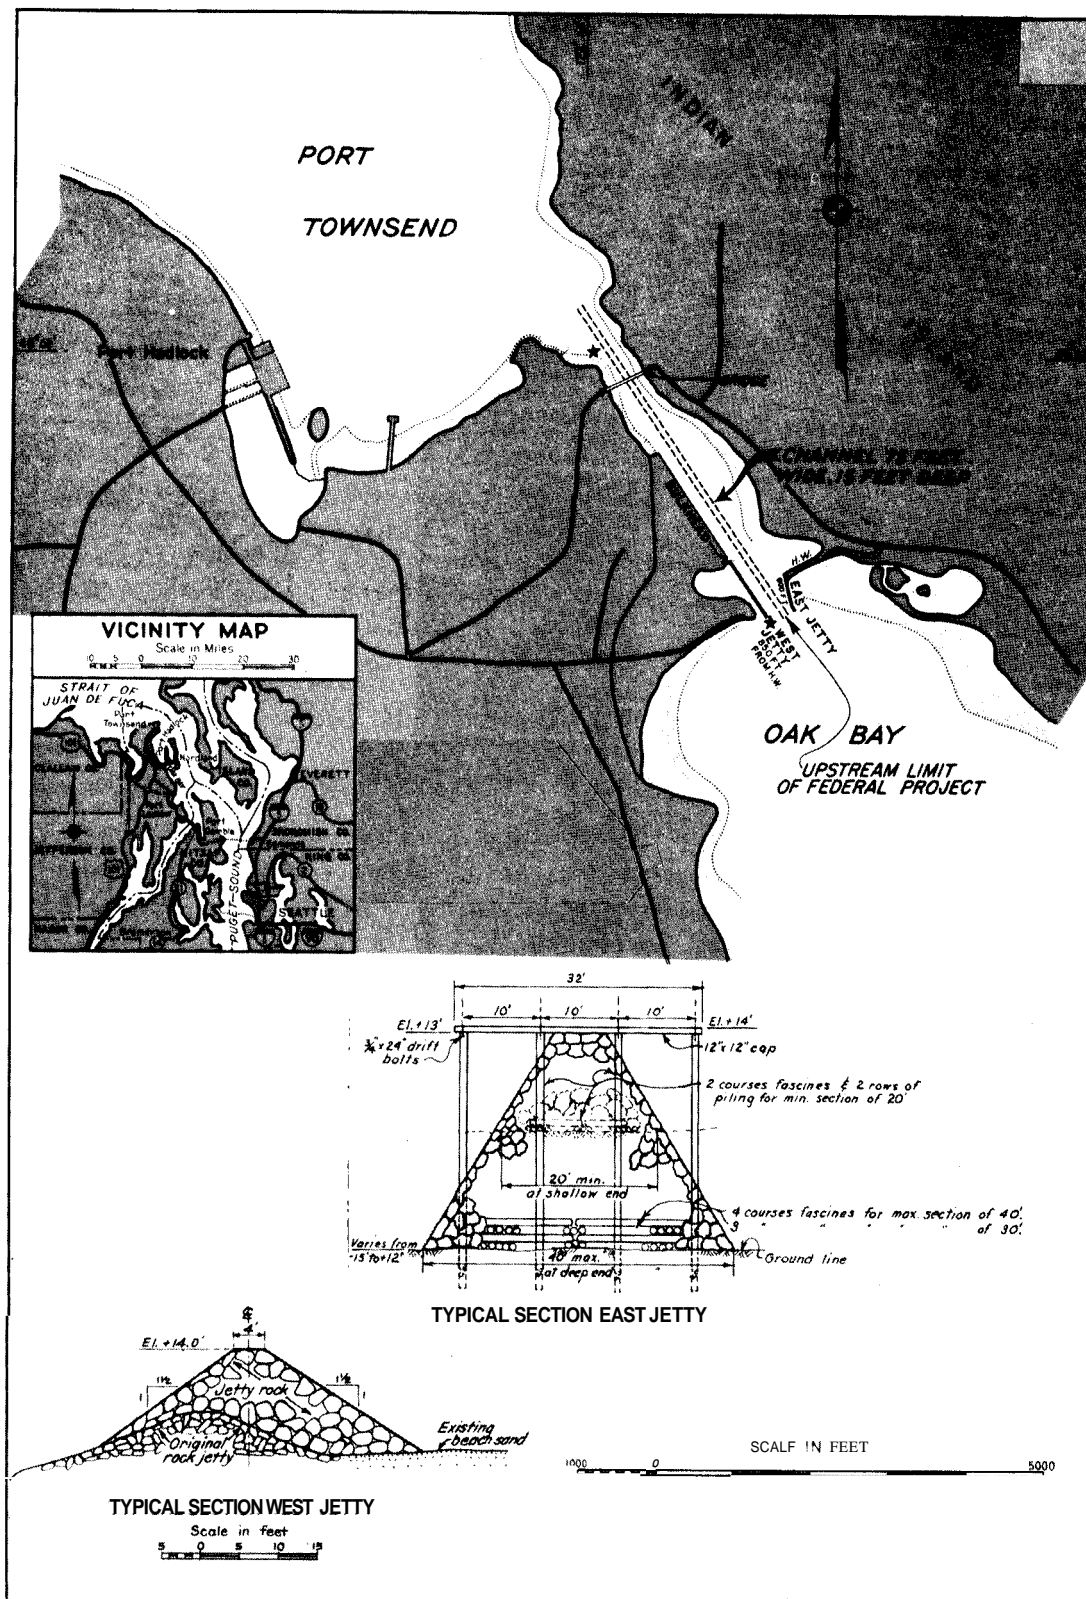
Figure 80. Site layout of waterway connecting Port Townsend and Oak Bay, Washington (revised 1979)

| Date( s) | Construction and Rehabilitation History |
|---|--|
| 1985 | The jetty layout and cross sections are illustrated in Figure <b>80</b> . There is no record of repairs or rehabilitation since <b>1961</b> . The west jetty is in good condition. The east jetty shows some deterioration but is stable and functional. |

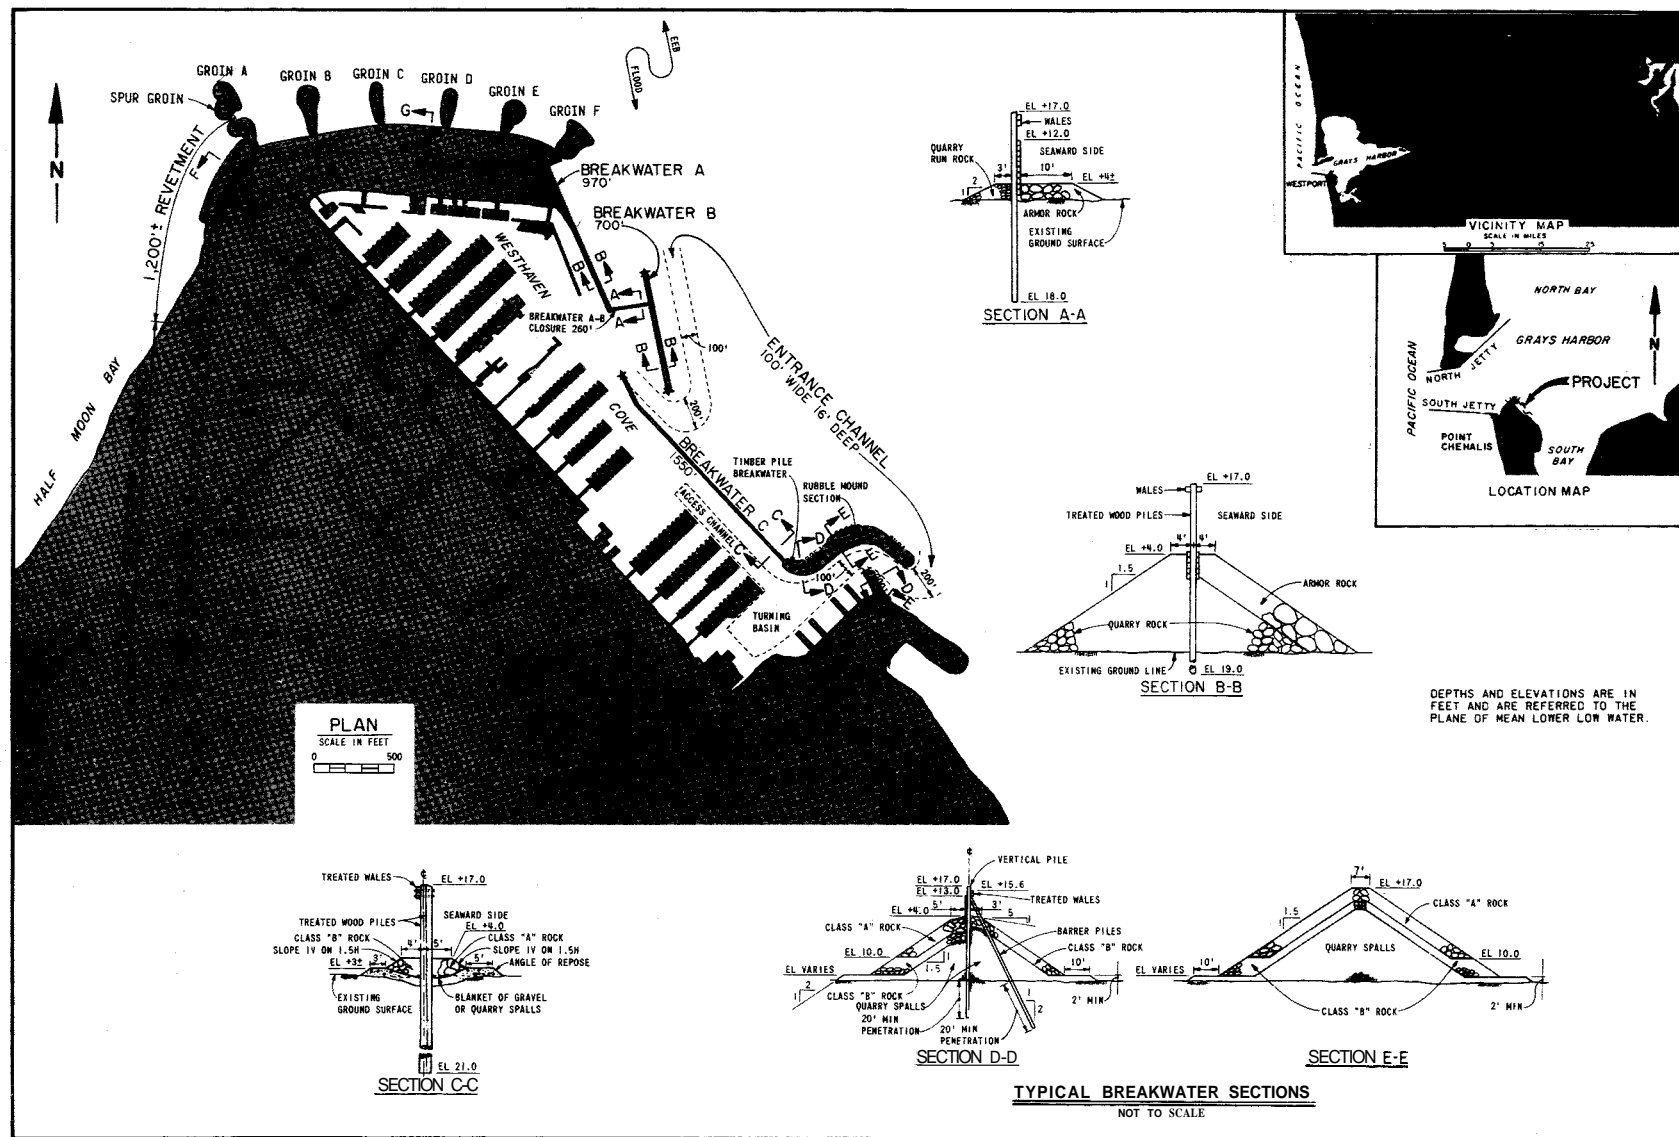
Figure 81. Site layout of Westhaven Cove Small-Boat Basin, Washington (revised 1979)

| Date(s) | Construction and Rehabilitation History |
|---|---|
| 1985 | The basin layout and cross sections of the breakwaters are illustrated in Figure 81. Breakwaters are in reasonably good repair and appear to be functioning properly. |
